Wascana Centre Authority

Comprehensive Review Project

Building and Infrastructure Assessments

September 2012

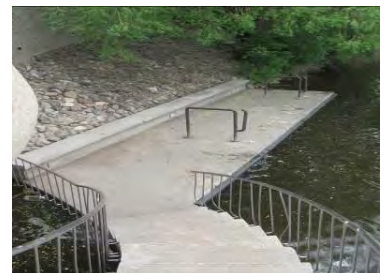
At the Willow Island overlook on the mainland and at Willow Island, the dock systems each consist of cast in place concrete slabs and steel mooring posts anchored to the slabs. The mainland structure was installed in 1964. The slab at Willow Island was recently reconstructed and WCA staff advise that the wooden access ramp will be replaced soon. Both docks are in

good condition. The slab on the mainland is cracked and the concrete bench on the slab is also cracked. The railing down to the dock is damaged and requires repair. Mooring posts on the mainland slab are loose and require tightening.

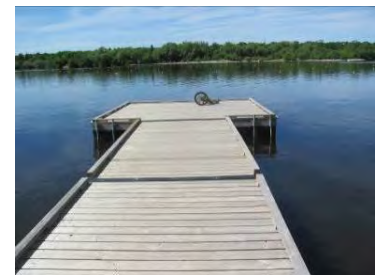
There are seven floating docks at the Wascana Canoe Club. Year(s) of construction are unknown. Four docks are constructed of 2'x6' decking supported on 2'x8' cross members at 2' on centre atop plastic flotation bins. Two docks are constructed of plywood on two layers of 2'x6' framing, and one dock is constructed with plywood on 2'x6' framing with 2'x4' side rails. There is also a small length of gabion retaining wall system along the north area. Four of the docks are in fair to poor condition due to deteriorated timbers and connections either missing or damaged.

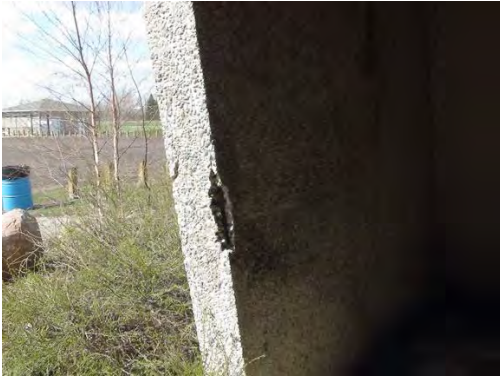
Wall Panel spalling-Detail-Exterior

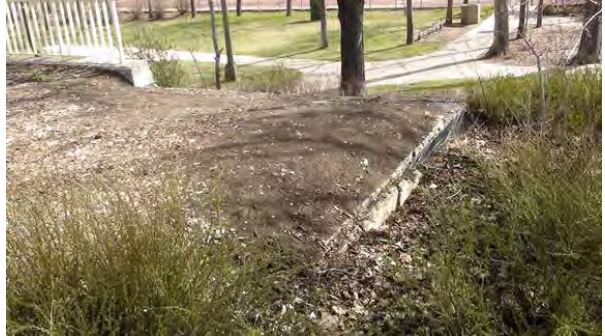
Membrane Ground Roof-Detail-Exterior

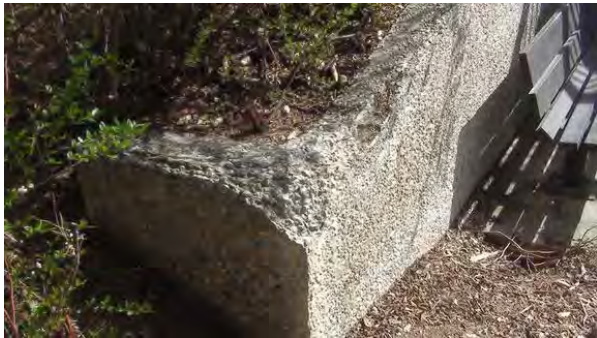
Wall Panel cracking-Detail-Exterior

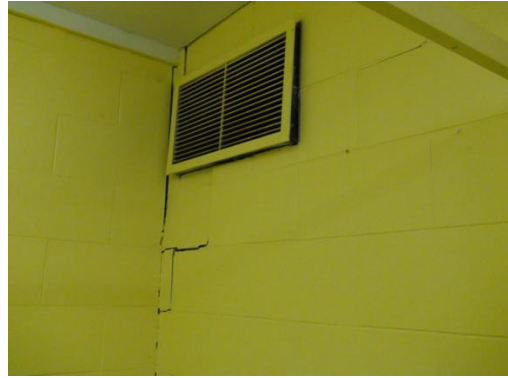
Stress crack-Detail-Interior

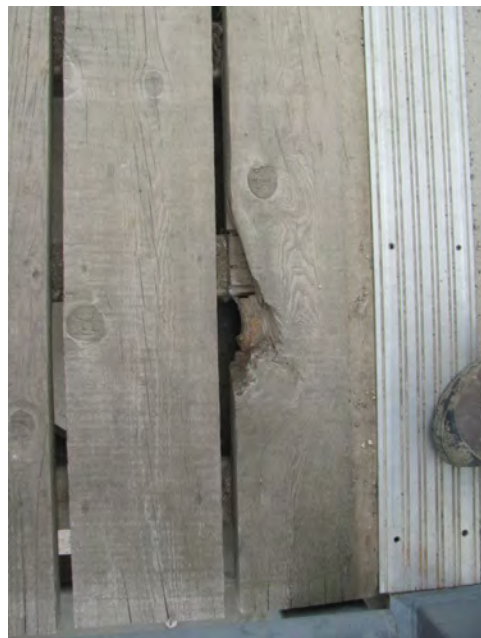
LoosePlankandTransition-Detail_Exterior
